SCOPIto

High School

Dec 3, 2020

Building

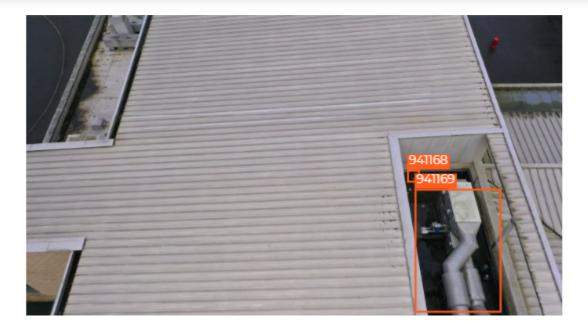
Andrew Eio:Vent pipe grill is missing

941169 Severity: 3 Debris

Andrew Eio:Build up of debris and moss

PRemedy action: Need to add a grill

PRemedy action:
Needs to the cleared out

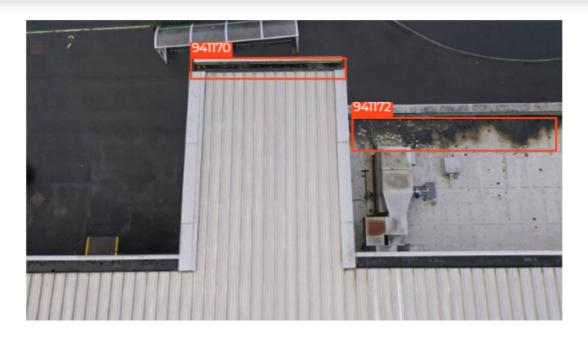
941170 Severity: 4 Gutter issue

Andrew Eio: gutter is blocked

941172 Severity: 4 Gutter issue

Andrew Eio:

Water seems to be pooling indicating a blocked drain

Remedy action:
Needs to bet cleared

PRemedy action: Needs to be inspected

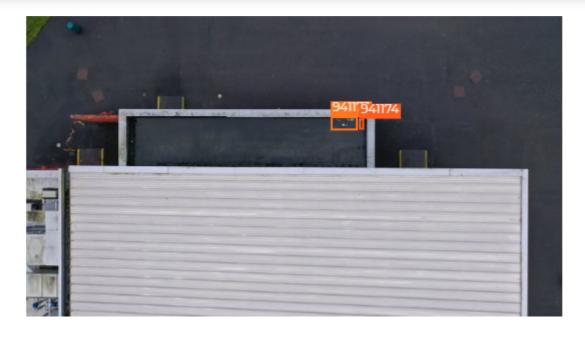
Andrew Eio: Debris on roof

941174 Severity: 3 Gutter issue

Andrew Eio:

drain seems to be blocked

Remedy action:
Needs to be removed

${\mathcal B}$ Remedy action:

Needs to be checked to make sure that the drain is not blocked

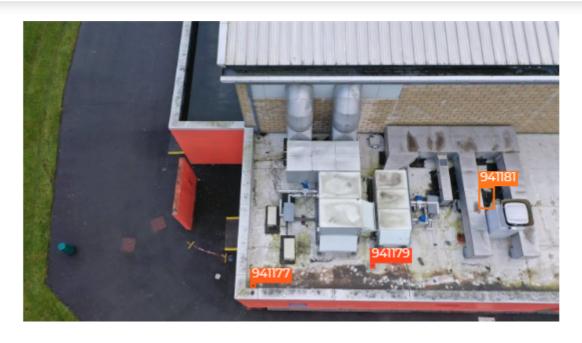
File name:
 DJI_0022.JPG
 Altitude:
 76.12f

941177 Severity: 3 Gutter issue

Andrew Eio: Missing grill

941179 Severity: 4 Missing Cover

Andrew Eio: Missing Vent cover

941181 Severity: 2 Vegetation

Andrew Eio:Build up of moss

Remedy action:
Need to install a grill

PRemedy action:
Need to install a anew vent cover
