Natural Power Demo Data

Report date:	Type:	Company:	Annotations:
Dec 1, 2020	Wind Turbine	Scopito Demo 1	35

Natural Power Demo Data - Summary

****This is a DEMO report****

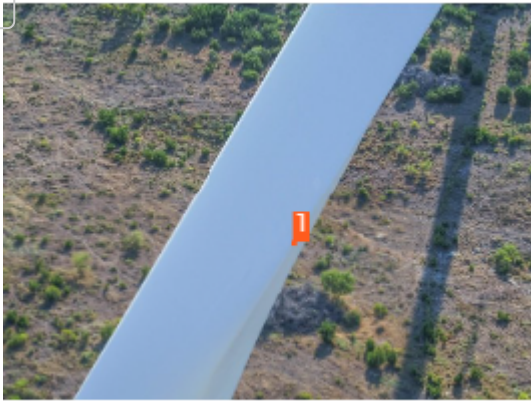
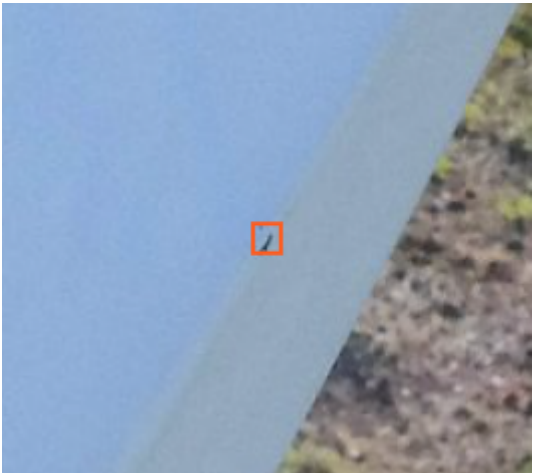
Issue Type:		Gel coat chip		Severity:		<div><div></div><div></div><div></div><div>3</div><div></div><div></div></div>	
Distance from root:		0.2m		Size:		26mm x 27mm	
<div><div></div>Comments:</div> <div>Chris Rawnsley: Gel coat chip on TE</div>				<div><div></div>Remedy Action:</div> <div>Repair within 6 months</div>

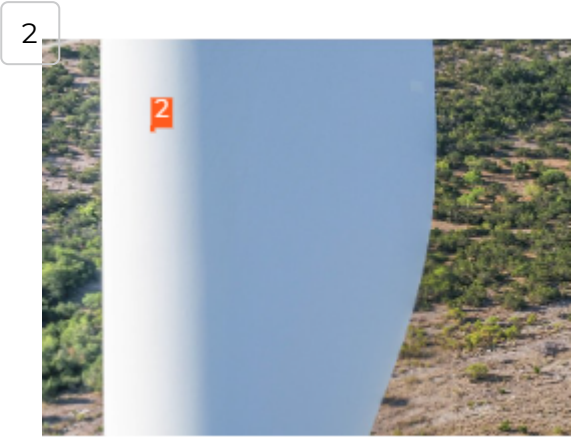
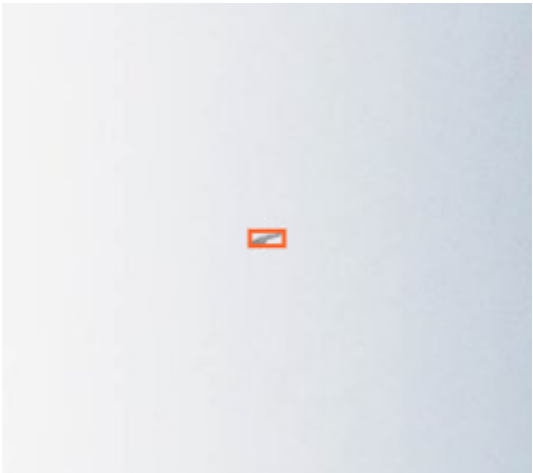
Issue Type:	Gel coat chip	Severity:	<div><div></div><div></div><div></div><div>3</div><div></div><div></div></div>
Distance from root:	0.2m	Size:	31mm x 15mm
<div>Comments:</div> <div>Chris Rawnsley: Gel coat chip</div>		<div>Remedy Action:</div> <div>Repair within 6 months</div>

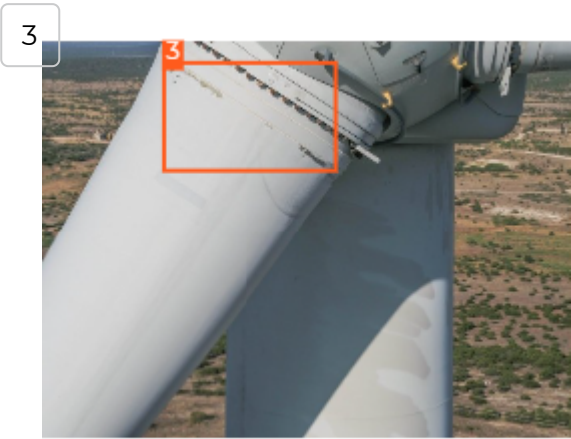
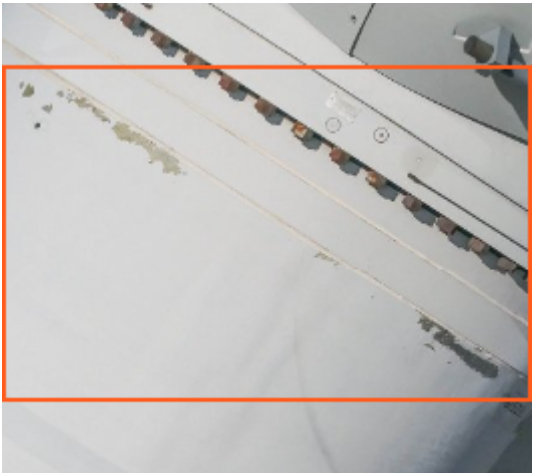
Issue Type: **Damage - Gel Coat** | Severity: 3

Distance from root: **0.1m** | Size: **1785mm x 1139mm**

Chris Rawnsley:
Peeling gel coat on root end with exposed laminate.

Repair within 6 months

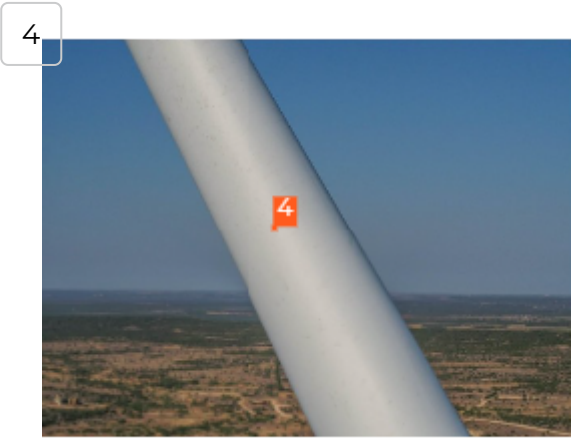
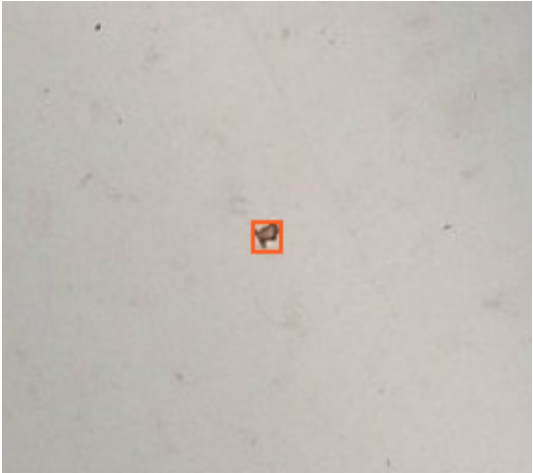
Issue Type: **Gel coat chip** | Severity: 3

Distance from root: **11.2m** | Size: **26mm x 27mm**

Chris Rawnsley:
Large gel coat chip on LE toward the root

Repair within 6 months

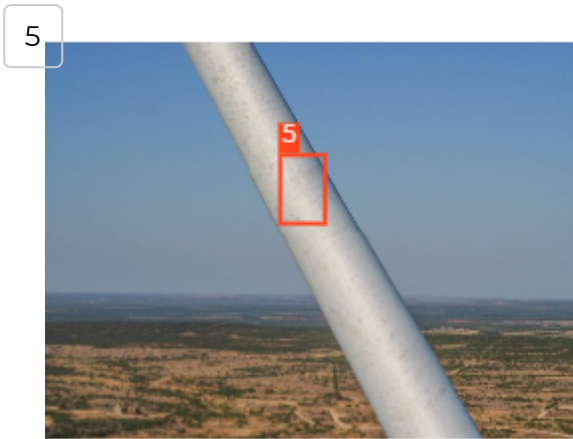
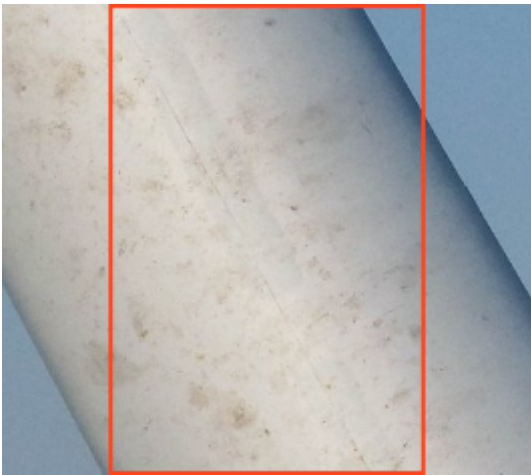
Issue Type:	Crack	Severity:	<div><div></div><div></div><div></div><div></div><div>4</div><div></div></div>
Distance from root:	18.8m	Size:	494mm x 739mm
Comments:		Remedy Action:	
Chris Rawnsley: Possible failed LE crack repair.		Repair within 3 months

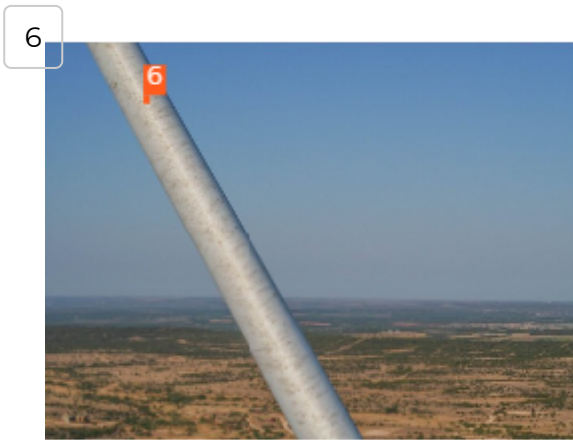
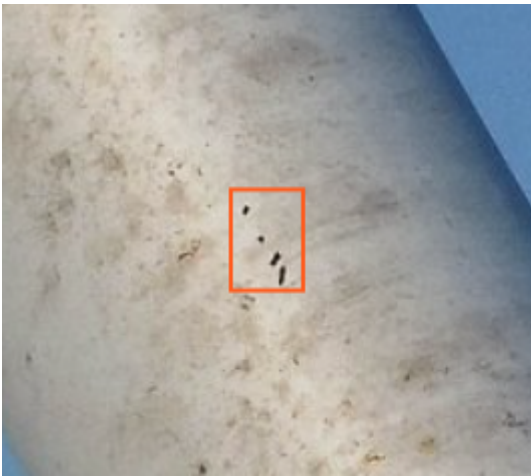
Issue Type:	Gel coat chip	Severity:	<div><div></div><div></div><div></div><div>3</div><div></div><div></div></div>
Distance from root:	24.7m	Size:	64mm x 88mm
Comments:		Remedy Action:	
Chris Rawnsley: Gel coat chips in LE		Repair within 6 months

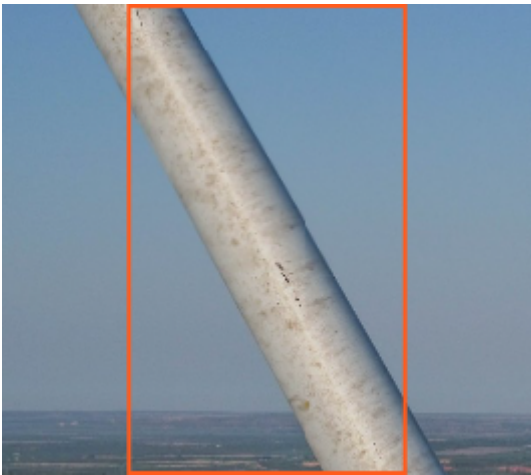
Gel coat chip

3

26.4m

1318mm x 2227mm

Chris Rawnsley:
Multiple gel coat damages on LE

Repair within 6 months

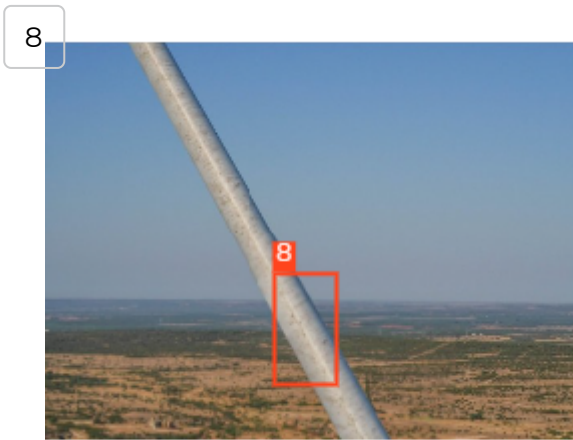
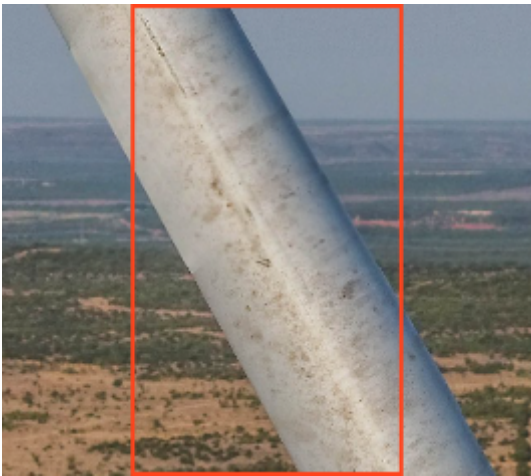
Crack

4

29.3m

672mm x 1168mm

Chris Rawnsley:
Area of expesed laminate and LE bondline with possible damage to bond line, also showing a possible LE crack.

Repair within 3 months

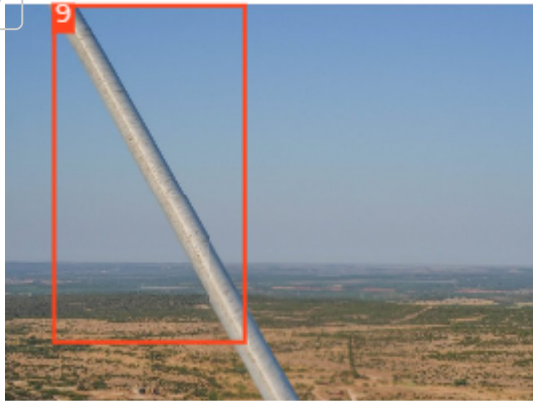
Crack

4

33.8m

1980mm x 3473mm

Further evidence of LE crack, along with multiple gelcoat chips.

Repair within 3 months

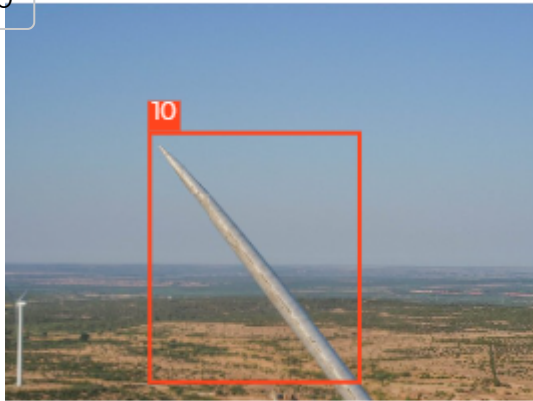
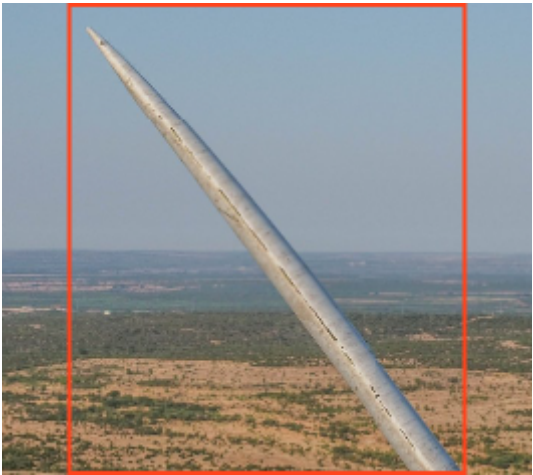
Damage - Gel Coat

4

38.4m

2174mm x 2575mm

Further gelcoat damage along the LE bond line towards the tip, along with damages that carry onto the shell.

Repair within 3 months

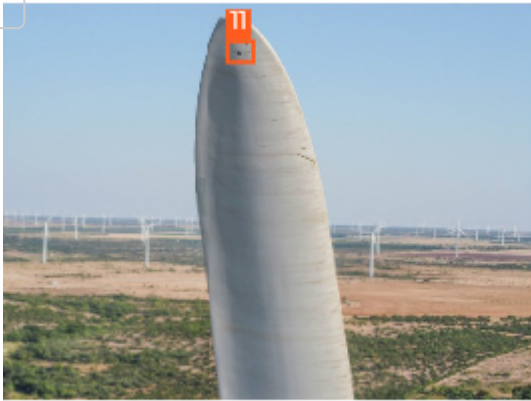
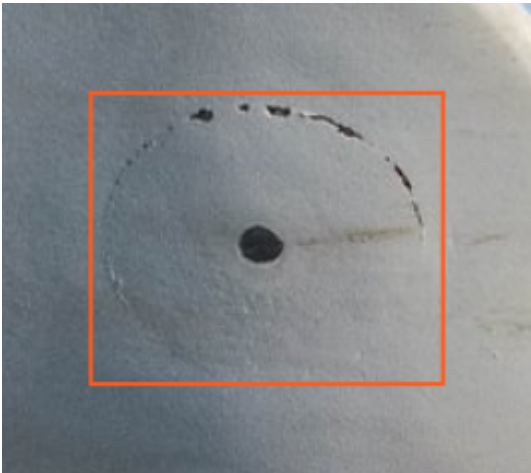
Damage - Gel Coat

3

27.7m

300mm x 250mm

Gelcoat damage around outer edge of LPS receptor.

Repair within 6 months

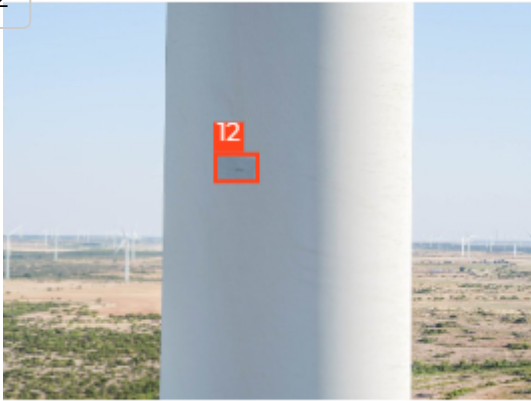
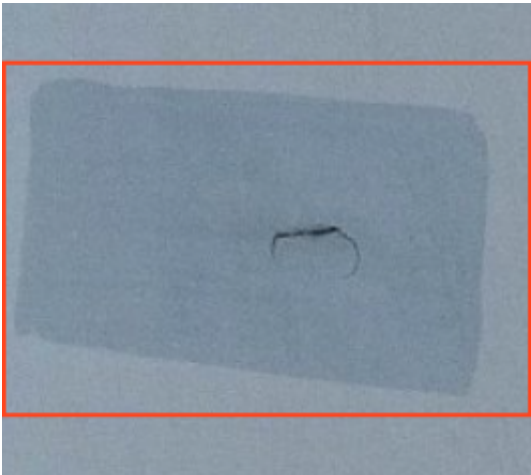
Crack

4

12.6m

467mm x 314mm

Possible failed repair, crack in shell.

Repair within 3 months

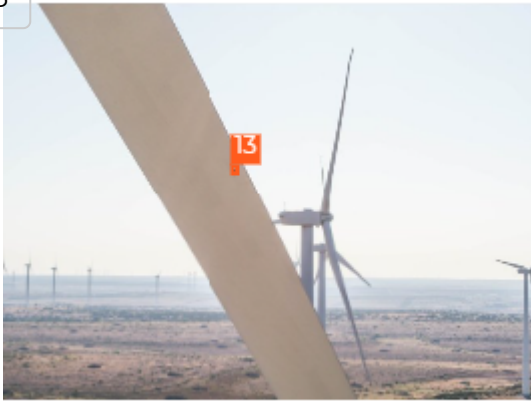
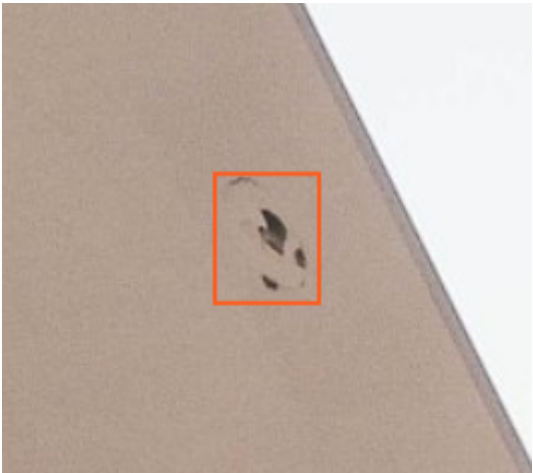
Issue Type: **Damage - Gel Coat** | Severity:

Distance from root: **28.6m** | Size: **90mm x 112mm**

Chris Rawnsley:
Gecoat on receptor damaged

Repair within 6 months

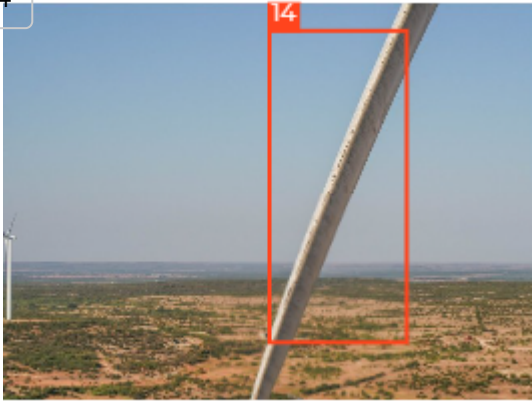
Issue Type: Crack | Severity: 4

Distance from root: 36.0m | Size: 1436mm x 3218mm

Chris Rawnsley:
Large area of LE erosion concentrated on the bond line, Possible crack.

Repair within 3 months

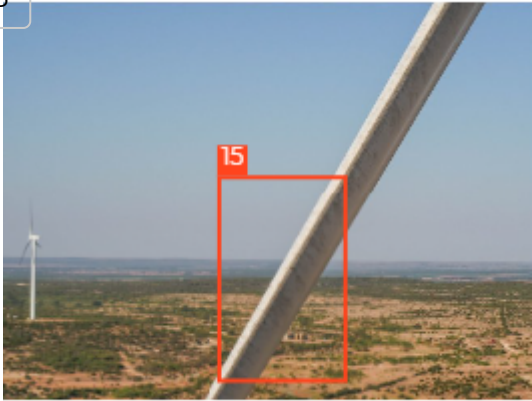
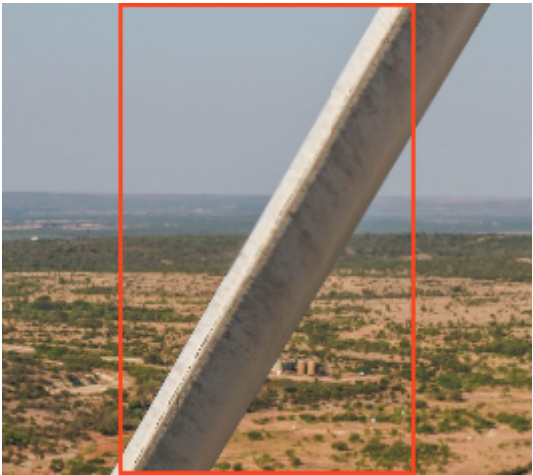
Issue Type: Damage - Gel Coat | Severity: 4

Distance from root: 31.4m | Size: 1323mm x 2111mm

Chris Rawnsley:
Further LE gelcoat damage along bond line.

Repair within 3 months

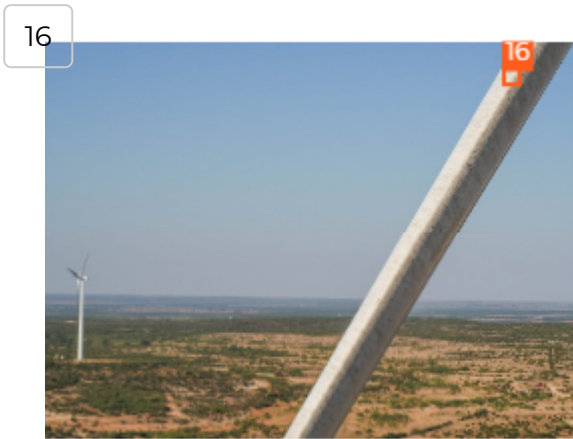
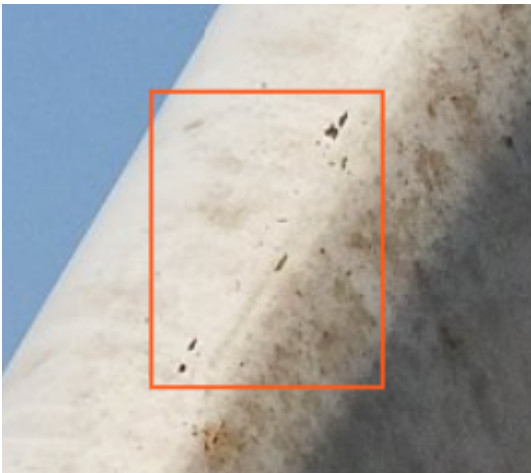
Gel coat chip

3

27.0m

198mm x 254mm

Chris Rawnsley:
Multiple LE gel coat chips.

Repair within 6 months

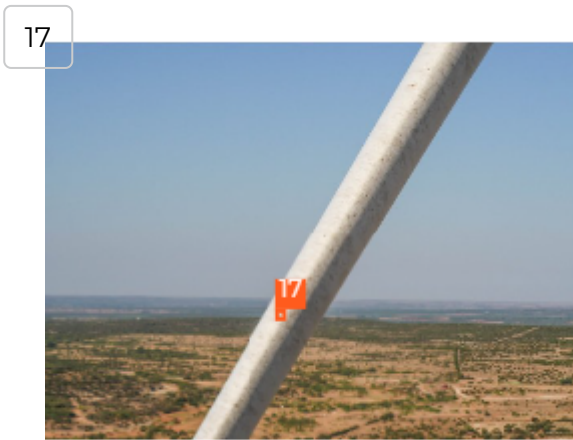
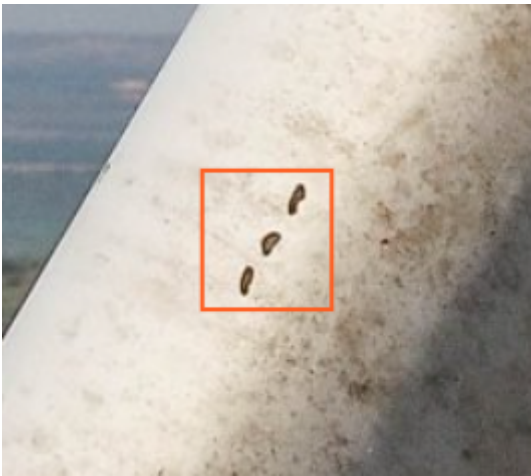
Gel coat chip

3

22.5m

112mm x 120mm

Chris Rawnsley:
Multiple large gelcoat chips.

Repair within 6 months

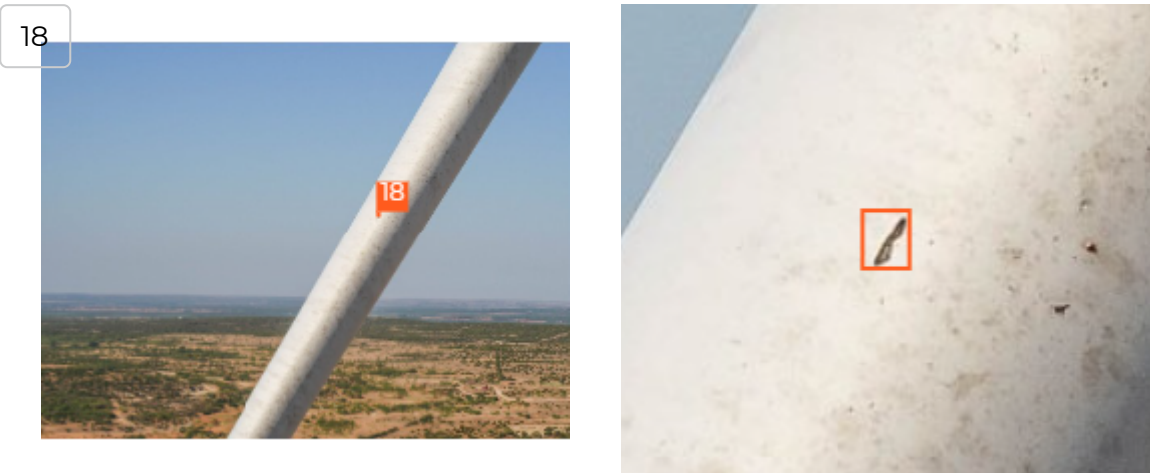
Issue Type:	Gel coat chip	Severity:	<div><div></div><div></div><div></div><div>3</div><div></div><div></div></div>
Distance from root:	19.4m	Size:	42mm x 52mm
Comments:		Remedy Action:	
Chris Rawnsley: Large gelcoat chip		Repair within 6 months

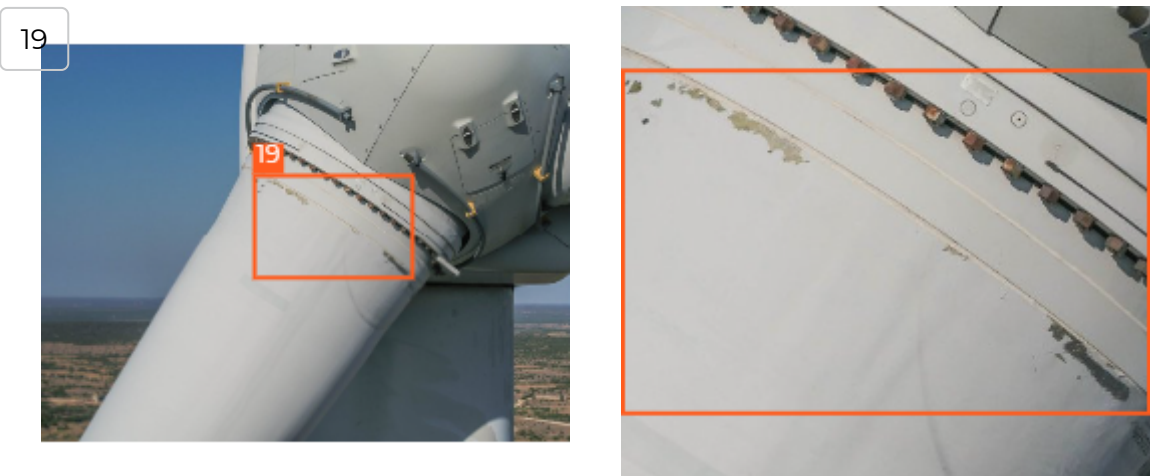
Issue Type:	Damage - Gel Coat	Severity:	<div><div></div><div></div><div></div><div>3</div><div></div><div></div></div>
Distance from root:	1.6m	Size:	1646mm x 1079mm
Comments:		Remedy Action:	
Chris Rawnsley: Multiple areas of damaged gelcoat around the root, laminate visible.		Repair within 6 months

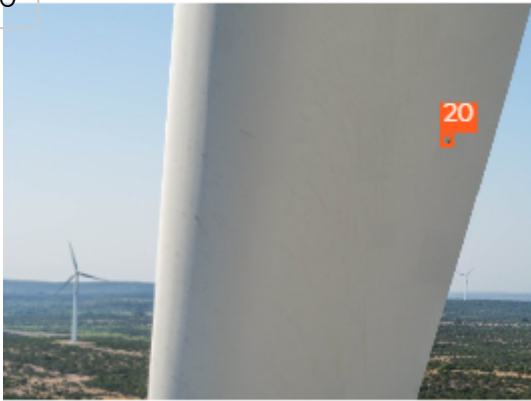
Issue Type: **Damage - Gel Coat** | Severity: 3

Distance from root: **6.4m** | Size: **144mm x 149mm**

Chris Rawnsley:
Gel coat damaged around LPS receptor

Repair within 6 months

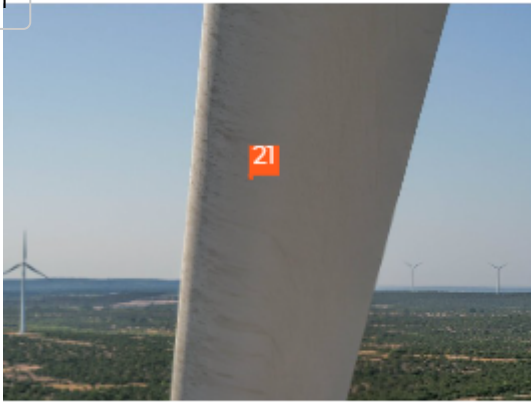
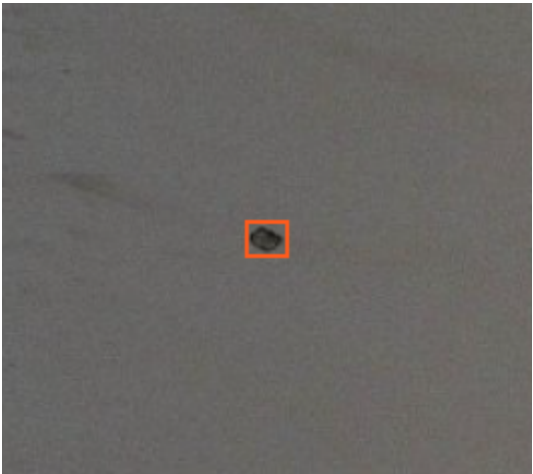
Issue Type: **Gel coat chip** | Severity: 3

Distance from root: **16.5m** | Size: **36mm x 31mm**

Chris Rawnsley:
Large gelcoat chip on shell.

Repair within 6 months

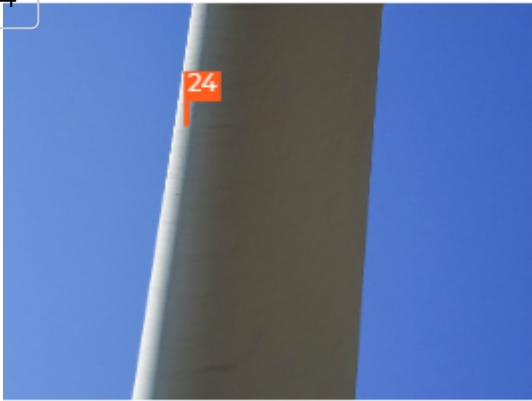
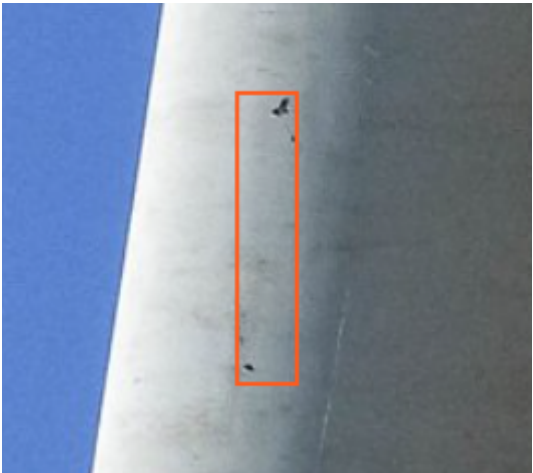
Issue Type: Gel coat chip | Severity: 3

Distance from root: 14.7m | Size: 53mm x 250mm

Chris Rawnsley:
2x Gelcoat chips

Repair within 6 months

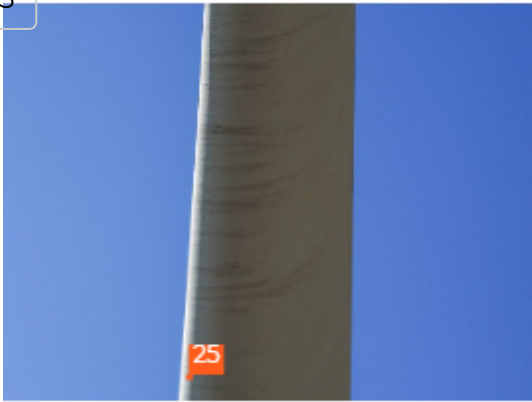
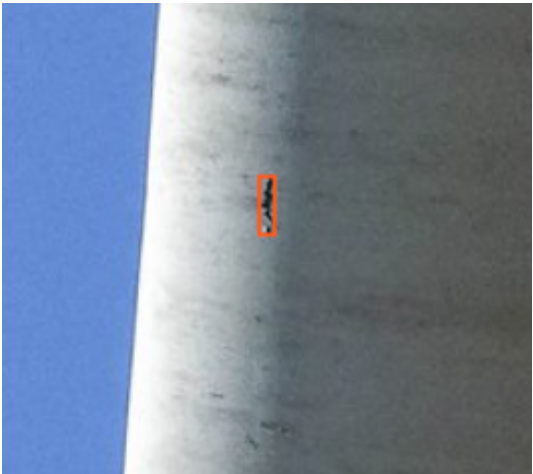
Issue Type: Damage - Gel Coat | Severity: 3

Distance from root: 23.4m | Size: 15mm x 52mm

Chris Rawnsley:
Gelcoat damage on previous repair

Repair within 6 months

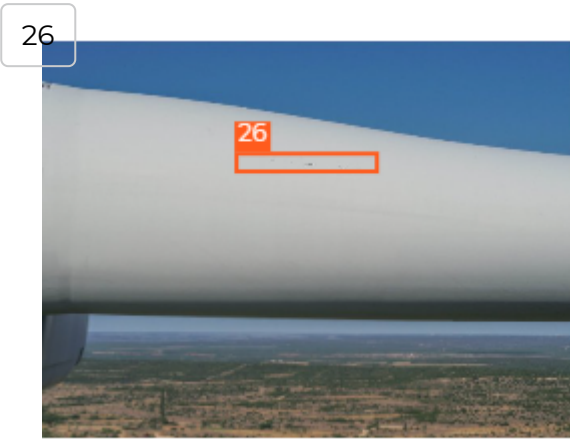
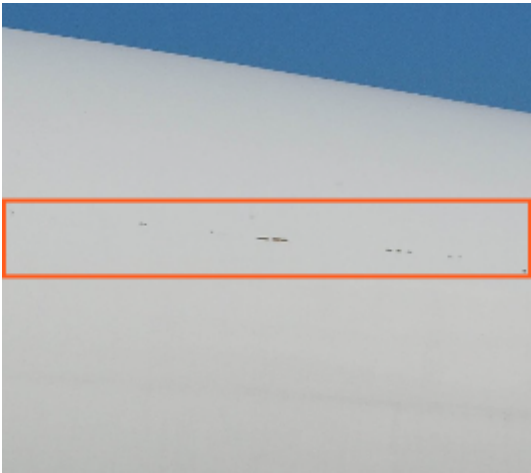
Issue Type:	Gel coat chip	Severity:	<div><div></div><div></div><div></div><div>3</div><div></div><div></div></div>
Distance from root:	0.3m	Size:	1468mm x 221mm
Comments:		Remedy Action:	
<p>Chris Rawnsley:</p> <p>Gelcoat chips toward the root, likely air bubbles within the original gelcoat.</p>		<p>Repair within 6 months</p>

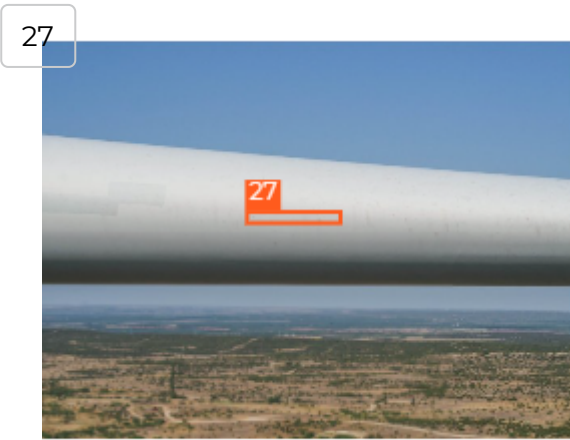
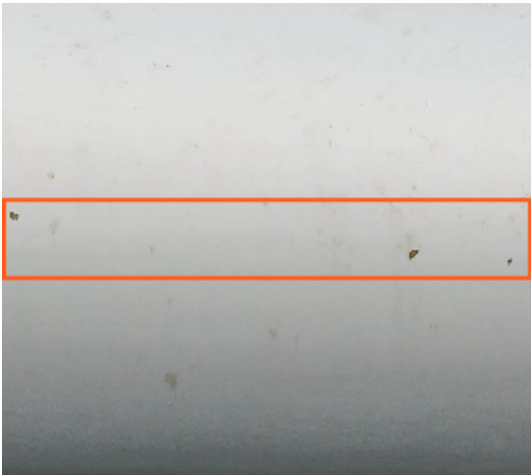
Issue Type:	Gel coat chip	Severity:	<div><div></div><div></div><div></div><div>3</div><div></div><div></div></div>
Distance from root:	7.4m	Size:	989mm x 153mm
Comments:		Remedy Action:	
<p>Chris Rawnsley:</p> <p>3x Large gelcoat chips</p>		<p>Repair within 6 months</p>

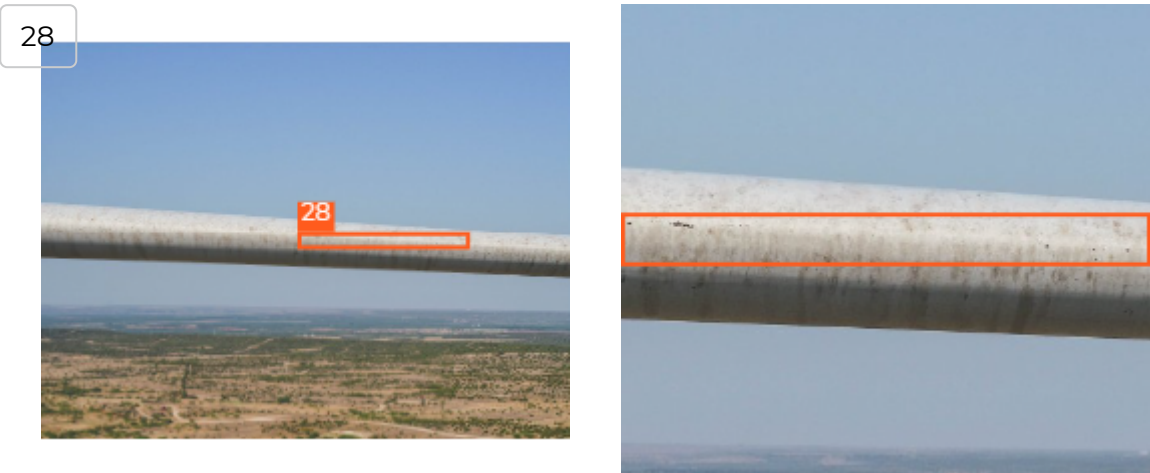
Issue Type:	Gel coat chip	Severity:	<div><div></div><div></div><div></div><div>3</div><div></div><div></div></div>
Distance from root:	21.0m	Size:	1754mm x 177mm
<div>Comments:</div> <div>Chris Rawnsley: Multiple LE gelcoat chips</div>		<div>Remedy Action:</div> <div>Repair within 6 months</div>

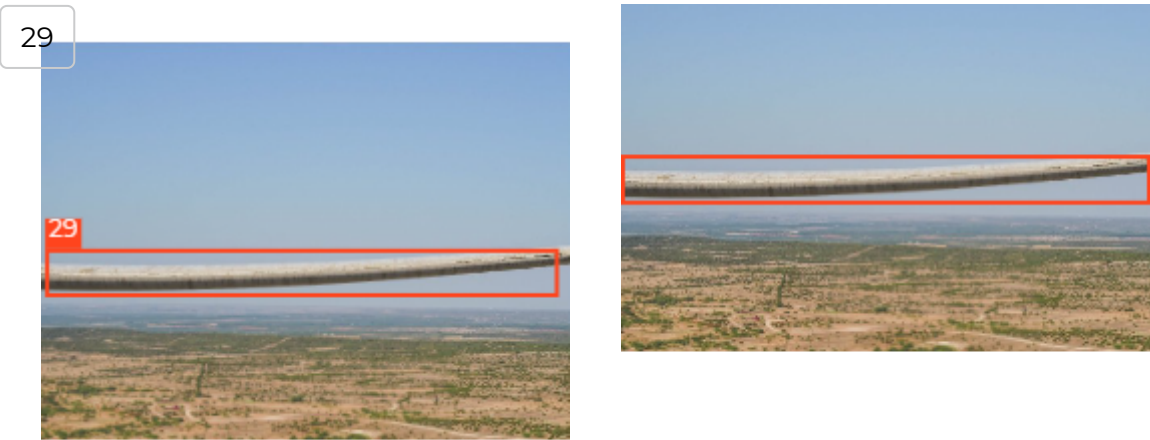
Issue Type:	Damage - Gel Coat	Severity:	<div><div></div><div></div><div></div><div></div><div>4</div><div></div></div>
Distance from root:	30.6m	Size:	5225mm x 492mm
<div>Comments:</div> <div>Chris Rawnsley: Large area of damaged gelcoat along LE bond line with multiple areas of eroded bond line.</div>		<div>Remedy Action:</div> <div>Repair within 3 months</div>

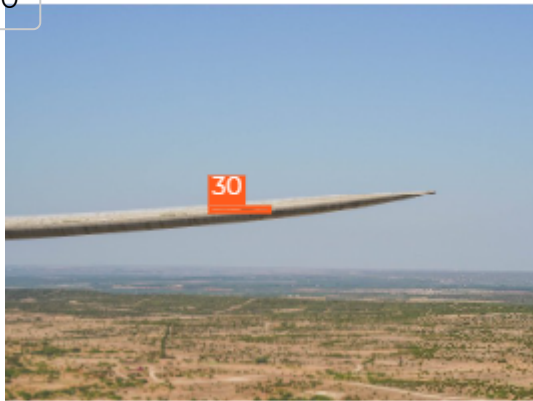
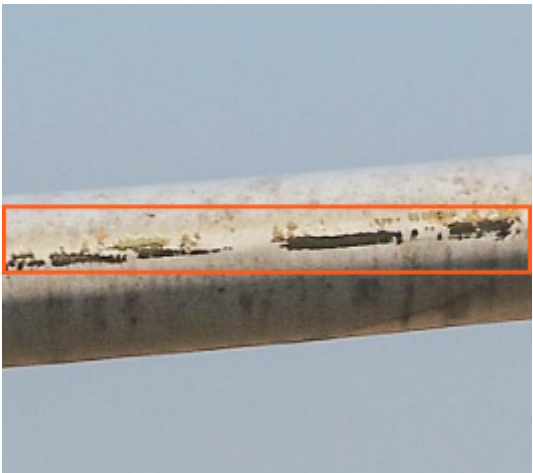
Crack

3

32.0m

645mm x 84mm

Chris Rawnsley:
Damaged gelcoat and possible crack in
LE bondline.

Repair within 3 months

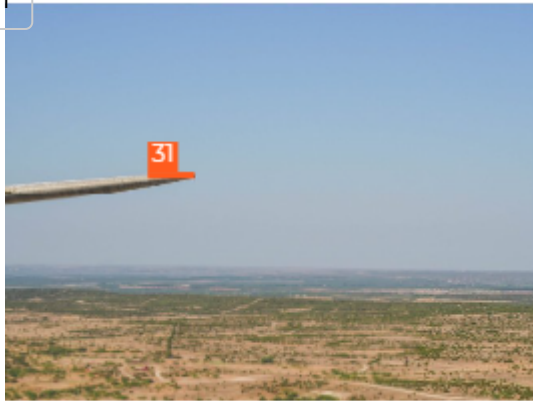
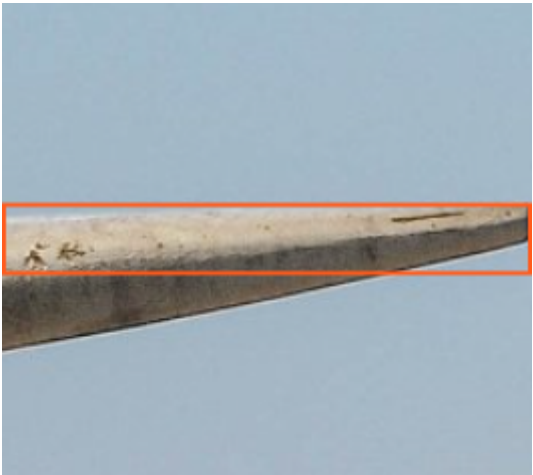
Damage - Gel Coat

3

33.3m

472mm x 64mm

Chris Rawnsley:
Damaged gelcoat on LE towards the tip

Repair within 6 months

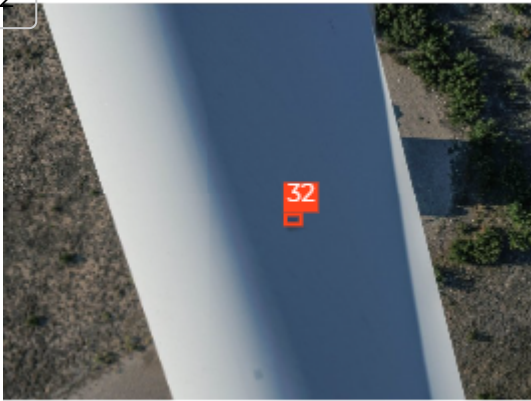
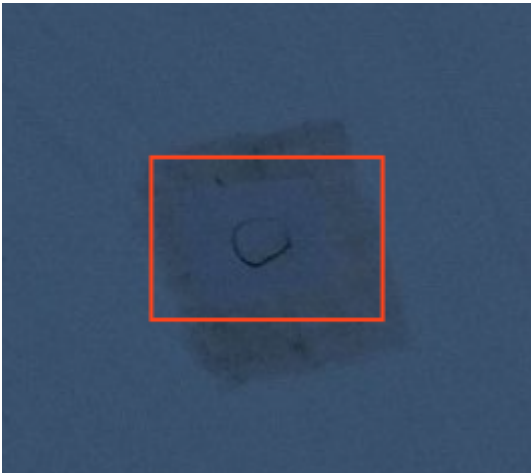
Damage - Fiber

4

9.8m

198mm x 141mm

Chris Rawnsley:
Possible failed repair on shell.

Repair within 3 months

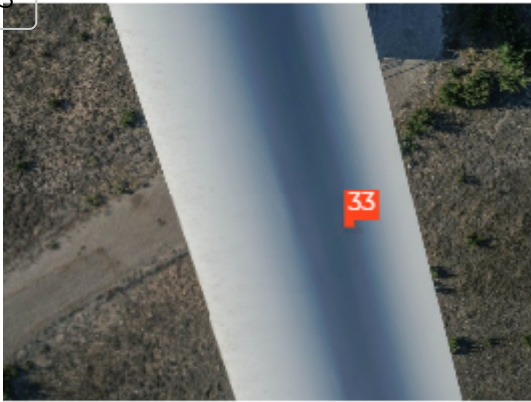
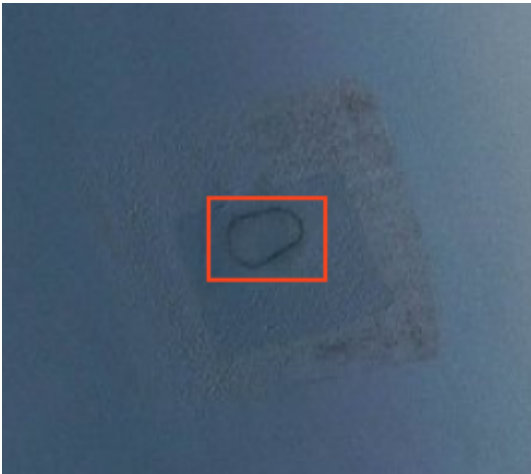
Damage - Fiber

4

17.1m

101mm x 72mm

Chris Rawnsley:
Possible failed repair on shell.

Repair within 3 months

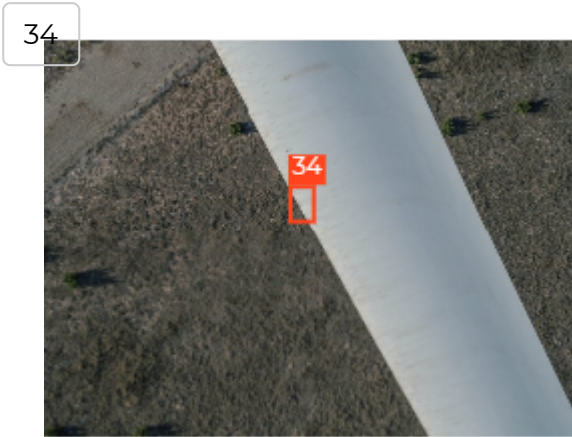
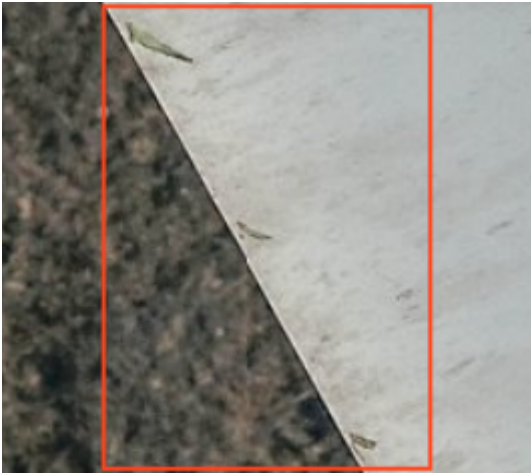
Damage - Fiber

4

27.2m

279mm x 395mm

Chris Rawnsley:
3 x large chips with visible laminate,
likely outer laminate damage.

Repair within 3 months

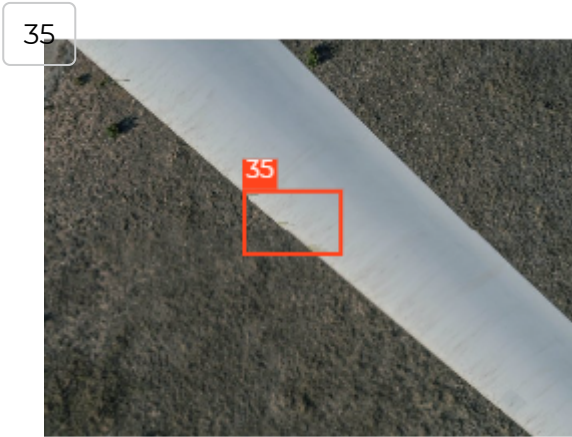
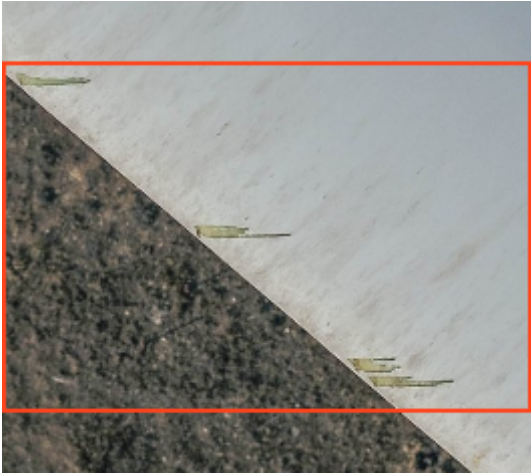
Damage - Fiber

4

30.1m

1022mm x 678mm

Chris Rawnsley:
4 x large chips on LE, with laminate
visible. Likely outer laminate damaged.

within 3 months
